ANALYSIS OF DAMAGED TURBINE BLADES OF THE ENGINE MPM 20

Jozef Čerňan^{1)*}, Marián Hocko¹⁾, Miroslava Cúttová¹⁾, Karol Semrád¹⁾

¹⁾ Technical University of Košice, Faculty of Aeronautics, Košice, Slovakia

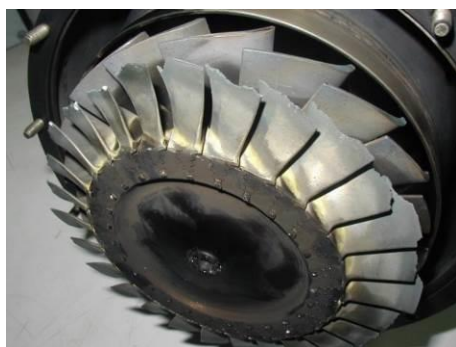
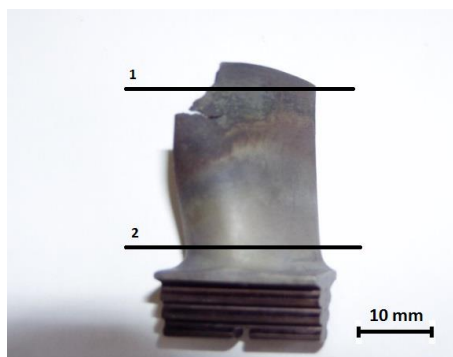
Throttling the air flow was carried out sequentially in 4 steps from 0 % up to 83 % in each case for about 50 seconds. During the last test a permanent damage of the turbine disc containing 27 blades around its periphery occurred. All turbine blades were destroyed by the breaking parts of the peaks as it is shown in **Fig 1a, b**.

Fig. 1 a, b Appearance of the turbine disc and one destroyed blade with cutting planes (“1, 2”)

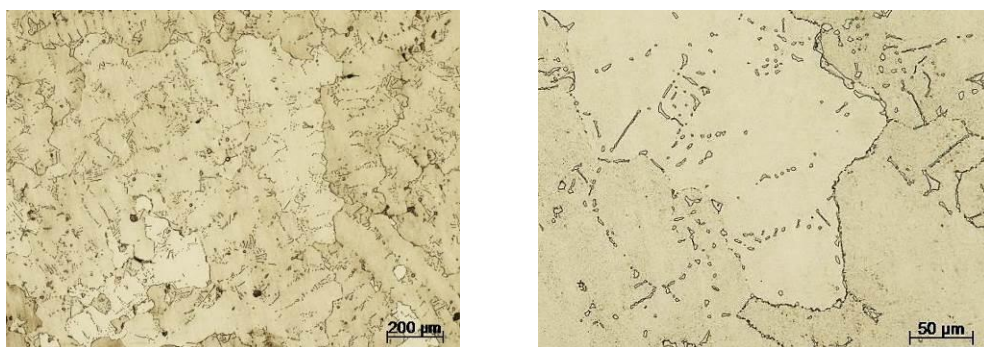
The metallographic-microscopic analysis was performed in the blade material section in the place of the fracture. The microstructure observed at low magnification shows the typical features of a regular dendritic structure - **Fig. 2a, b**, related to the manufacture by casting.

Fig. 2a,b Microstructure of the material with the feature of casting structure and in more detail

In this case it is a pressure casting, during which the coarse structure is achieved and the grains reach the size of 400 – 600 μm. The detailed examination of the microstructure refers to the carbidic network precipitated within the grains as well as in the grain boundaries. As we already published [11] the blade material is an alloy of Soviet production, according to the GOST standards available as the ZhS-6K. The excluded carbides at the grain boundaries in the form of networks are mainly of the M₂₃C₆ type. The carbides within the grains may be of the MC nature with the dissolved elements such as Mo or a TiC(N) carbonitride. The used alloy also contains alloying elements for the base matrix reinforcing, such as Co, Al, Mo and W. The second group of elements, reinforcing the grain boundaries, consists of C, Cr, W, V, Ti [12, 13, 15]. The selection of individual precipitate particles and their corresponding EDX spectra are shown in **Fig. 3**.

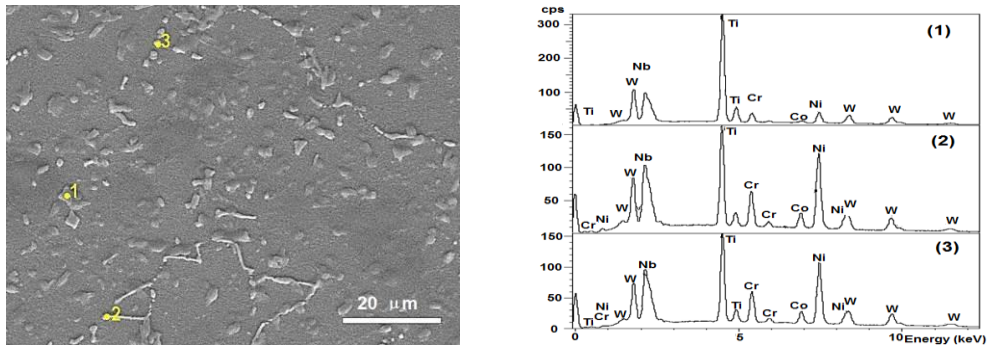
Table 2 shows the nominal chemical composition of the standard Soviet ZhS-6K alloy and the results of EDX semi-quantitative chemical analyses corresponding to investigated base material, over-heated zone and individual selected particles depicted in **Fig. 3**. There is a noticeable change in the chemical composition of the base material comparing to the standard ZhS-6K alloy due to the structural changes during the turbine service life.

Fig. 3 Position of selected particles for semi-quantitative EDX chemical analyses and their corresponding EDX-spectra

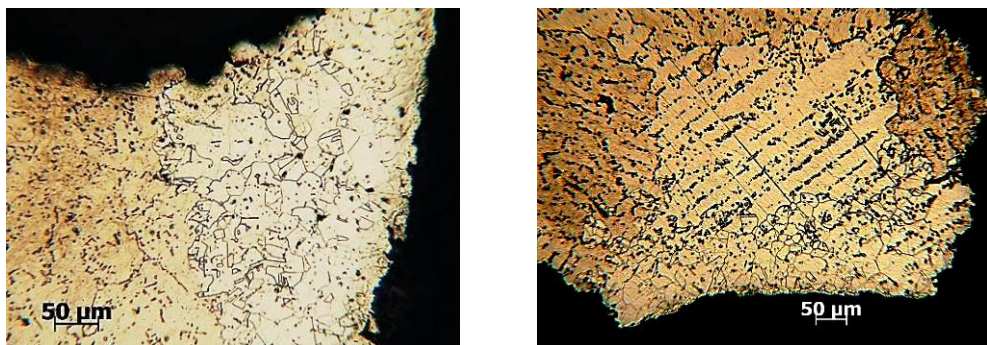
Observing the fracture area of the blade in **Fig. 4** it the bright white band at the edges of the structure can be seen. Its width is related to the overheating of the blade edges. This results into the apparent recrystallization of the microstructure, whereby the original grains are divided into a number of small grains forming a fine grain structure with a different etching capability [13]. This fact also refers to the change of the composition of the alloying elements and in a loss of strength. The level of this decrease can be partially inferred by the microhardness measuring. The basic material hardness was 513 HVm and after the overheating the value was only 368 HVm.

Fig. 4 a, b Recrystallization zone at two locations of the blade tip

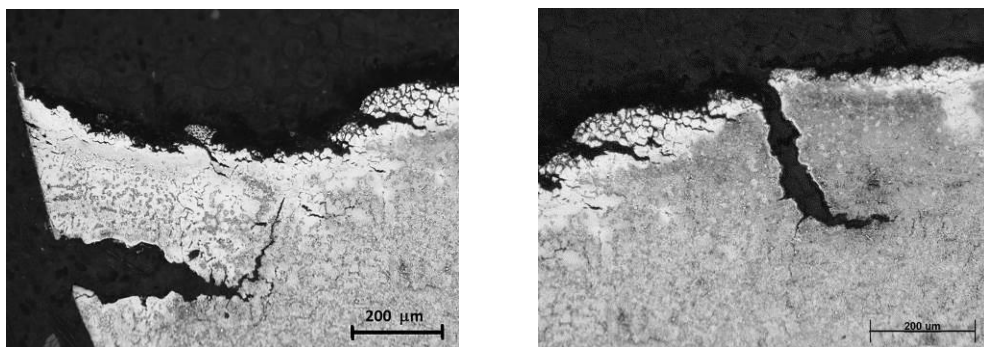
In addition to this effect at higher temperatures, there was a rapid reduction of the gap between the blade tip and the casing of the turbine. There occurred a friction and also to the deformation of the blade tip. This contributed to a further increase in the overall stress of the blades and to the cracks formation. Formation of these cracks was extensively supported by the intensive penetration of the oxygen into the grain boundaries, mainly due to its high affinity to carbides at the grain boundaries - **Fig. 5**. From a macroscopic point of view this phenomenon logically seems like the decarburization [14].

Fig. 5 Recrystallization zone and effects of the oxygen penetration into the grain boundaries

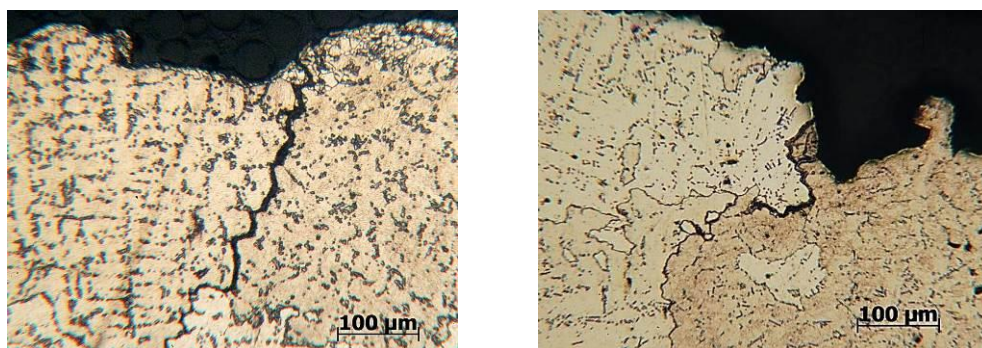
A significant contribution to this fracture has the fact that the blade was in its weakened tip during the collision with the inner casing of the gas turbine deformed. This is an explanation of the fact, that all the blades are damaged in this part. The fact is that the formation of the cracks and their distribution into the over-heated zone was apparently easier due to the deformation. In the rest of the blade, with no recrystallized microstructure the crack propagation can occur only by the path of the least resistance, that is, through the grain boundaries - **Fig. 6 a, b**.

Fig. 6a,b Intergranular cracks in the microstructure of the blade near the fracture

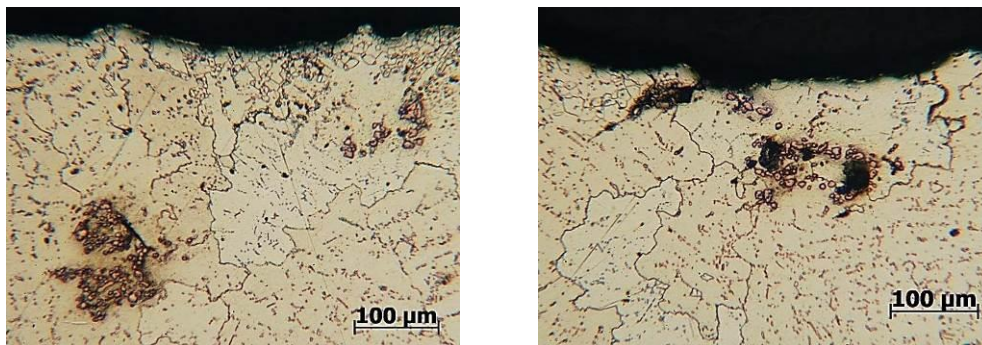
In addition to these aspects directly related to the fracture, in the microstructure were recorded also places where there was an evident disintegration of the original Ti-type carbide particles the size of 40–80 μm . These, have been divided due to the high temperature into the large number of small particles with the size of 5–15 μm . These locations are shown in **Fig. 7a, b**.

Fig. 7a,b The disintegration of titanium carbides in the blade microstructure

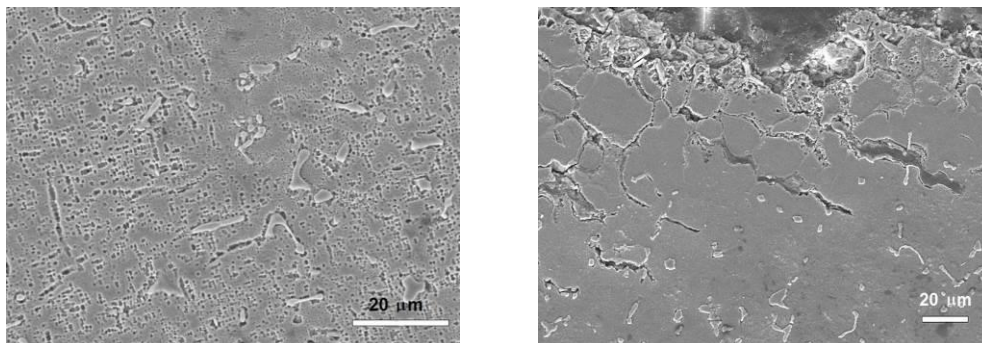
Such disintegration of these particles was observed just around the heat affected zone with the recrystallization of the original microstructure. It is evident that their role in the precipitation hardening was eliminated and the substantial weakening of the microstructure had to occur. Also, the observation using the scanning electron microscopy revealed the differences in the microstructure of the base material and the material in the heat affected zone. This is evidenced by the following images in **Fig. 8a, b**.

Fig. 8a,b Non-affected microstructure and heat affected area of the microstructure

Basic microstructure in **Fig. 8a** has the clearly visible carbides of various types and sizes inside the grains as well as at the grain boundaries. These carbides are in the heat affected zone of the microstructure hardly noticeable. However, the fine grain microstructure of the heat affected strip is well visible. The grain boundaries are surrounded by the intergranular cracks. The nature of the damage of the blades can be understood by studying the features of the fractographic fracture of the surfaces using the scanning microscope. **Fig. 9a** shows appearance of the whole width of the fracture. From the picture it is obvious that not a single fracture mechanism took place. It has all of the fractographical fracture features.

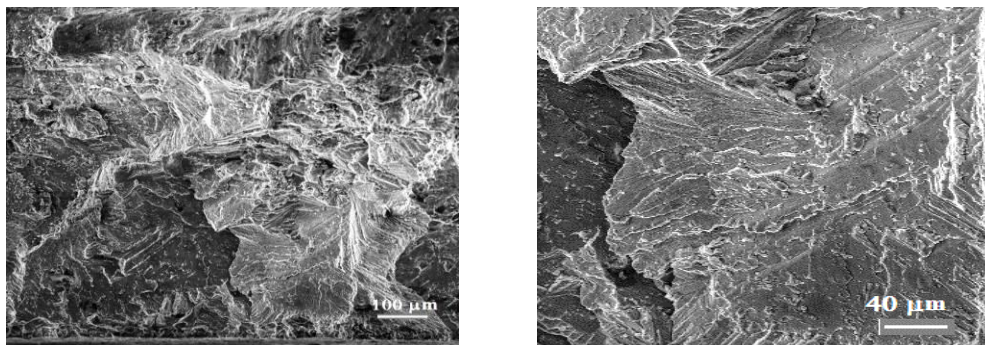
For example **Fig. 9b** shows a characteristic nature of the brittle fracture, in **Fig. 10a** there is an obvious fatigue character with visible striation facets and **Fig. 10b** shows a typical ductile fracture. It has to be noted that all of these fractographical features are marked by the fact that they took place at the increased temperature.

Fig. 9a,b The entire width of the blade fracture and brittle nature of the fracture

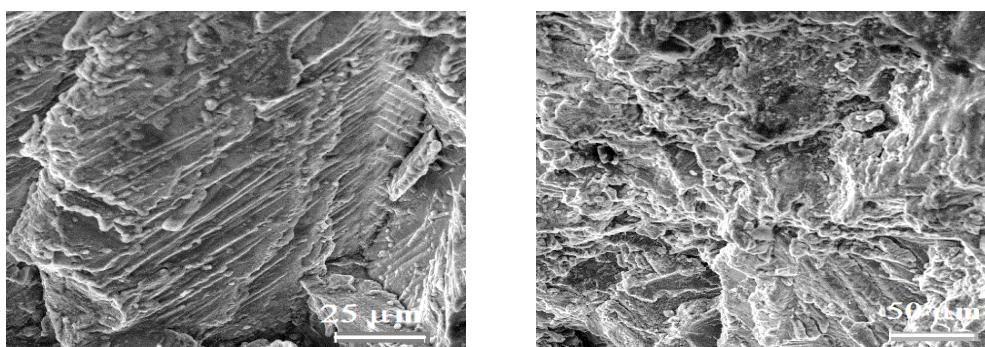
Fig. 10a,b Fatigue fracture character and ductile nature of the fracture
