RESEARCH PAPER

UTILIZATION OF ANALYTICAL METHODS FOR THE FAILURE ANALYSIS OF INJECTION MOLDED PART

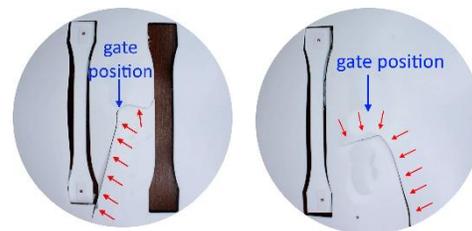
In the presented paper, a type of injection molded product from HDPE (Fig.1) affected by occurrence of cracks was investigated by mechanical, thermal testing and spectral analysis. Cover (outside diameter = 218 mm) made of commercial HDPE grade DOW HDPE KS10100 UE exhibits crack occurrence and propagation through central part of molding (Fig.2), before, during or short after installation and therefore could not meet the desired service lifetime. Suspecting not stable molding condition at the producer molding shop and the material quality issues a set of analytical tests was necessary to find out the cause of crack occurrence, as some batches of cover did not have any problem.

Fig. 1 Molded cover (inside)

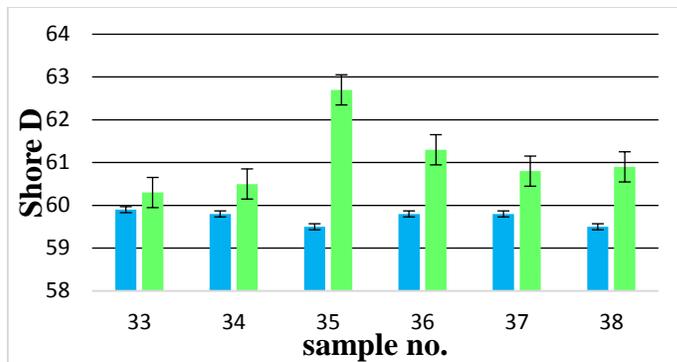
Fig. 3 Shore D results comparison for both sides of molding

Shore D hardness measurement was performed on samples No. 33, 34, 35, 36, 37, 38 and 38 (Table 2). Measurements of samples showed differences in hardness values depending on which side of the sample was measured. The top side of the samples (as received and marked) on which the sample number was placed is "blue" and the reverse side "green". The measured values listed in Table 2 do not show significant differences in hardness between the samples but the mean value on the outside 59.72 is lower than the Shore D hardness 61.08 observed on the inside of the molding. The calculated mean values of Shore D hardness (tab.2), and the graph (Fig.3) with standard deviation show difference trend between the "blue" and "green" side.

- Results from hardness measurement shows slightly difference and trend on all samples when comparing the inside and outside of the moldings. Difference between molding inside and outside is probably attributable to different mold temperatures during injection molding. However, this assumption could not be verified by processing data from supplier and further tests were considered unnecessary by the customer.

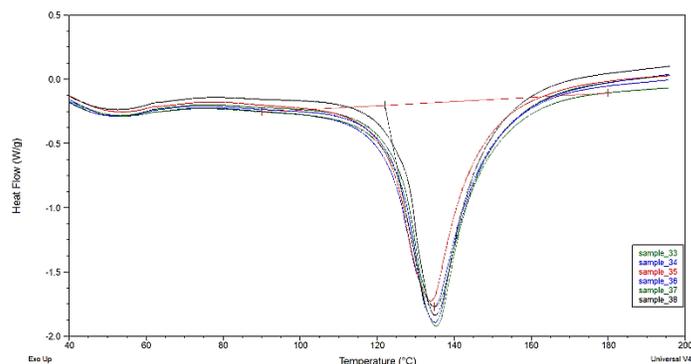
Fig. 4 DSC curves of measured samples

Data from DSC analysis are listed in Table 3. The results show that the melting temperature for individual samples is in the range from 133.93°C up to 135.37°C (Fig.4) and that corresponds to the HDPE polymer and no further peaks up to 200°C were observed. For samples no.33 and no.34 a higher degree of crystallinity was measured at level 71.92%, resp. 72.73%. Other samples taken from the moldings with crack achieve the measured crystallinity in the range from 67.19% up to 70.02%.

Obtained crystallinity results from DSC analysis shows strong correlation between degree of crystallinity and tensile elongation.

- DSC analysis provided values of melting temperature and degree of crystallinity. While the melting temperature remain in narrow range 133.93 - 135.37°C and no correlation between failure and melting temperature was observed, the influence of degree of crystallinity is obvious. Samples 33 and 34 have the crystallinity above 71.92% and samples from failure moldings have crystallinity lower than 70.02%.

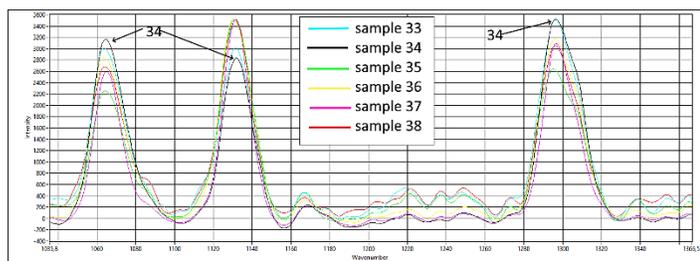
Fig. 5 Raman spectrum shifts of measured samples

Raman spectra of tested samples is presented in Fig. 5. Raman spectrum shift for samples in the range 1020-1550 cm⁻¹ was measured. The peaks of spectral shifts at 1065 cm⁻¹, 1130 cm⁻¹ and 1280 cm⁻¹ distinguish clearly the samples 33 and 34 with higher crystallinity level. Spectral peaks of samples 33 and 34 at 1065 cm⁻¹ resp. 1280 cm⁻¹ are highest among tested samples, whereas their peak at 1130 cm⁻¹ is the lowest. In Fig.5 are the spectral peaks of sample 34 with crystallinity of 72.73% marked with arrow.

exact value is obtained. The results from Raman spectroscopy match well to the results of the DSC analysis.

- Data from Raman spectroscopy and analysis of Raman spectra shifts show that a correlation between degree of crystallinity determined by DSC analysis and spectrum peaks at 1065 cm⁻¹, 1130 cm⁻¹ and 1280 cm⁻¹ is observable.
