RESEARCH PAPER

ATMOSPHERIC CORROSION BEHAVIOR OF HOT-DIP GALVANIZED AND CONTINUOUS GALVANIZED STEEL

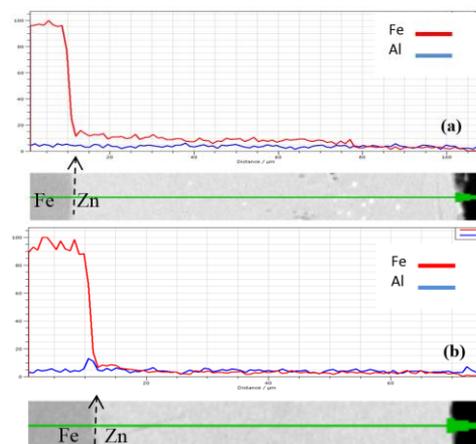
Fig. 2 The obtained line spectral EDS analysis results of BHDG (a) and CHDG (b) samples.

Fig. 2 shows EDS analysis data for Zn and Fe content through the cross sections of zinc layers. The formation of Fe₂Al₃ layer is clearly seen for CHDG sample, due to process, and this thin layer plays important role in adhesion and homogeneity of Zn layer on the steel substrate. Moreover, in the EDS line spectra analysis of CHDG sample, a peak was observed for Al content, during transition from substrate to galvanizing layer. This evidence was indicating to concentration of Al content in this region, as an interphase.

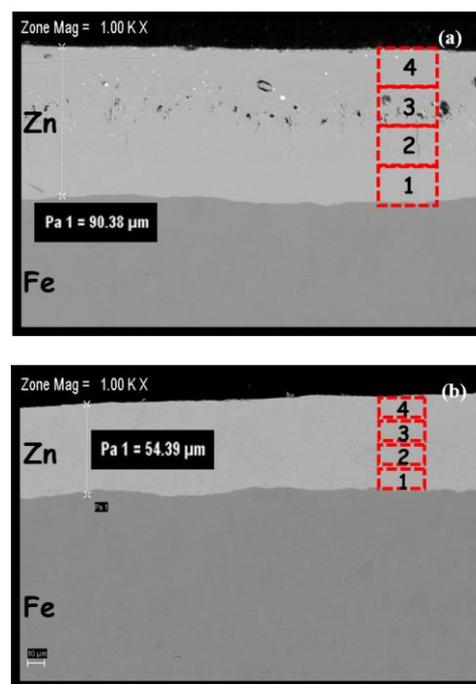
Fig. 3 The selected areas for cross sectional BHDG (a) and CHDG (b) samples from inside to the outside.

For further investigation, we have divided the galvanizing layers into 4 different zones (sections), beginning from the Fe/Zn interface to the top of coating layer. Then, distribution of Fe and Pb elements was analyzed for each section, shown in **Fig. 3** and the data was summarized in **Table 2**. Normally, the amount of Fe (w%) decreases gradually, from bottom to the top of galvanizing layers of both samples. The said iron content comes from the substrate, with diffusion Fe atoms through the freshly being formed Zn layer, in hot galvanizing bath. It was clear that BHDG process yields galvanizing layer with remarkably higher amount of iron, as well as lead content.

The presence of diverse elements has dramatic impact on mechanical, morphological and electrochemical properties of galvanizing layer. Lead content is more likely deposited as clusters at many places (white color in **Fig. 3**) of the coating. Even though there were small concentrations of aluminum, iron and silicon, the major component of these clusters was found to be lead. Moreover, there are similar results reported in

The clusters of lead stimulate formation of micro galvanic cells within the galvanizing layer, and deterioration is accelerated. Also, cross sectional inspection of BHDG sample clearly shows that there is serious number of defects within galvanizing layer, due to presence of considerably high amount of impurities (**Fig. 3**). Of course, the processing time and cooling

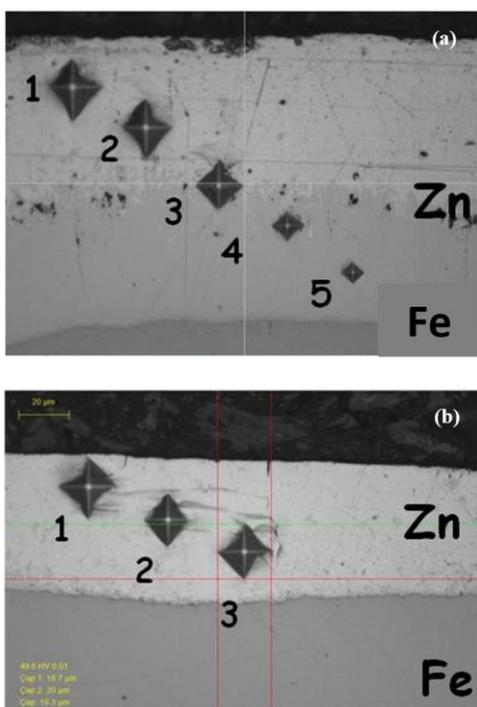
Fig. 4 Micro hardness test results along the cross side for BHDG (a) and CHDG (b) samples.

The hardness value changed dramatically along the cross section of BHDG sample's galvanizing layer, nearby the steel substrate it was 285 HV, decreased gradually and 50 HV was measured for the region near the top of coating (point 1). This situation was attributed to gradually changing iron content along the galvanizing layer, rather than the lead. Highest hardness value was measured near the steel substrate, where

the iron content was highest (8.86% by weight). The presence of iron increases the hardness value; moreover the hardness value decreases down to 42 HV on the top, where the iron content becomes 0.70% for CHDG sample. Then, the largest trace (indentation) was observed at point 1, after testing with square pyramidal diamond indenter. For galvanizing layer of the CHDG sample, micro hardness value changes very slightly (42-50 HV) starting from the steel/galvanizing layer interface through the top.

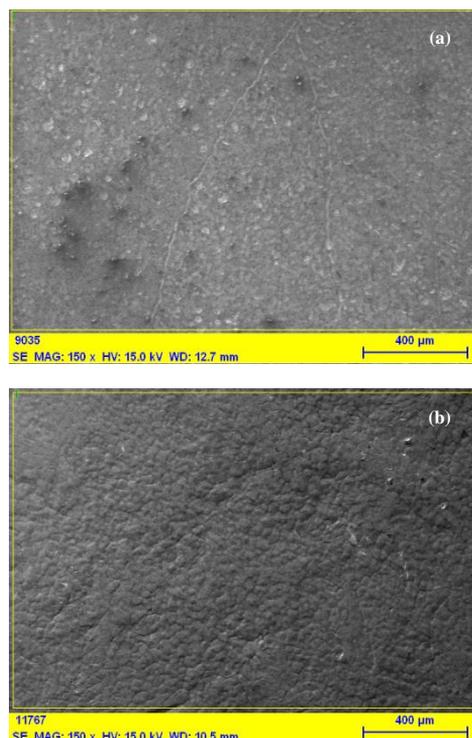
Fig. 5 SEM images of BHDG and CHDG samples prior to atmospheric corrosion tests.

Before exposure to atmospheric field, the sample surfaces were analyzed with SEM- EDS and the results are given in Fig. 5. From SEM images, the surface of BHDG was more likely homogenous, due to fact that there was Cr (III) passivation on the surface of CHDG sample. Cr (III) passivation process leaves a mixture deposit on the surface, where the major components are zinc oxide and chromium (III) oxide. Besides, the presence of oxide species was found on the surface of both samples, **Table 4**. In the case of BHDG sample, the galvanizing layer surface is oxidized in the open atmosphere, readily.

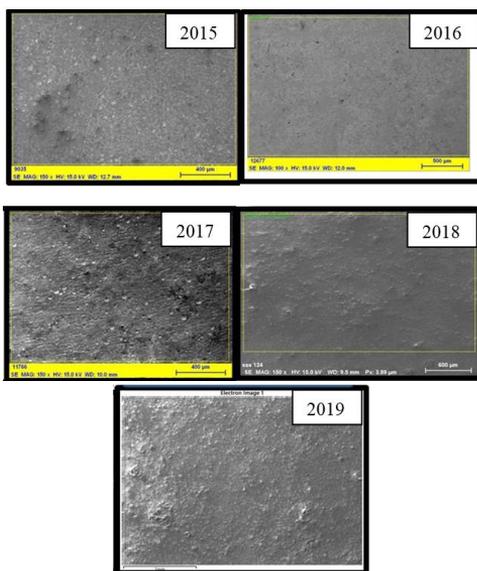
Fig. 6 SEM images of BHDG sample taken periodically for 5 years.

The field tests have been started in the year of 2015, and small pieces were cut off from the main body and brought to laboratory for detailed analysis, in the following years, periodically. After cleaning the surfaces with ethanol and rinsing in water, dried samples were prepared for SEM analysis; recorded results are presented in **Figs. 6** and **7**. General appearance of surfaces changed with time, due to deposition of atmospheric corrosion products and co-deposition of some extra contaminations.

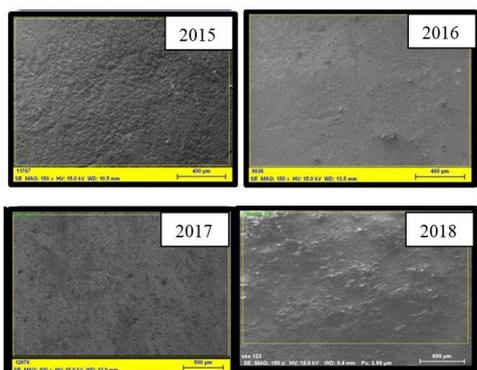
Fig. 7 SEM images of CHDG samples taken periodically for 5 years.

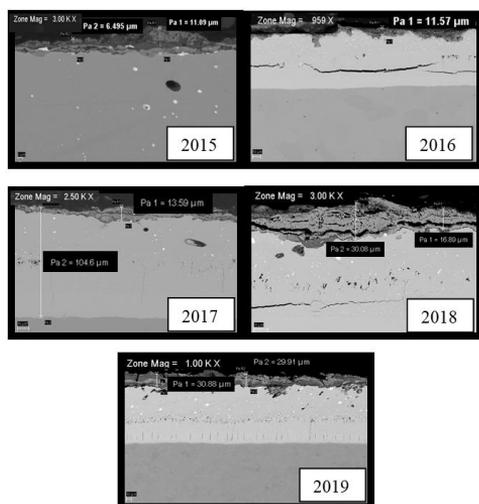
Fig. 8 Cross-section SEM images of BHDG samples taken periodically for 5 years.

For better understanding the severity of corrosion caused damage on galvanize layers and structure of corrosion products depositing on the surface, the samples were analyzed cross sectional. The SEM results are presented in Figs. 8 and 9, for the cross sections of BHDG and CHDG samples exposed to industrial marine atmosphere (C4 class). It was noted that 1 year exposure was sufficient for severe corrosion of thick galvanizing layer of BHDG sample. Highly porous and rough layer of corrosion products was detected on the surface, also, local severe damages were observed. Moreover, some lateral cracks were determined within the galvanizing layer of BHDG sample. The damaged areas due to local galvanic cells appeared to be white spots and/or pitting. As discussed previously (section 3.1.), the BHDG sample's galvanizing layer includes

significant amount of iron and lead. The bottom part of zinc layer is rich of iron, while the lead rich clusters are more likely to be found on the top. Typically, the galvanic cells occur between the lead rich clusters and zinc matrix, and then severe local corrosion damages occur, where the corrosive electrolyte solution can succeed to these parts.

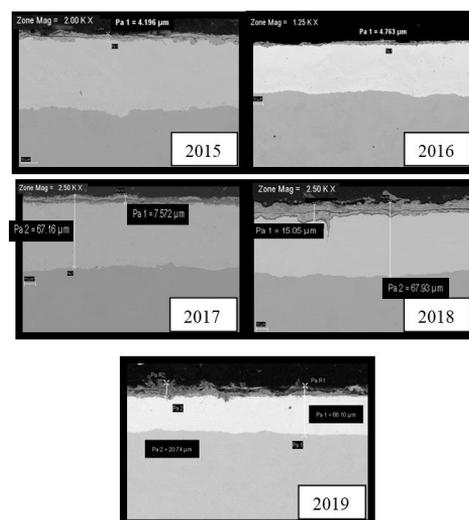
Fig. 9 Cross-section SEM images of CHDG samples taken periodically for 5 years.

We have previously shown that the iron content influence the micro hardness value dramatically, along the height of zinc layer. Therefore, this situation may cause those cracks either during forming process or stress cracking corrosion within the coating when the corrosive solution reaches to this region. It was noted that the formation of micro-cracks happen within the lower region of this type of galvanic layer, therefore it was

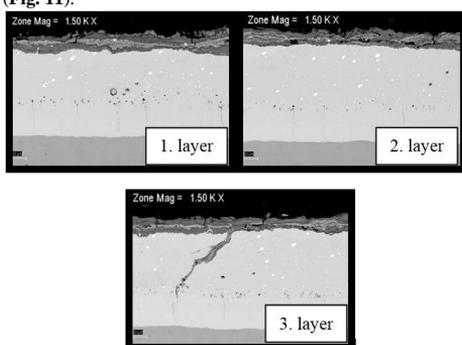
Fig. 10 SEM analysis into the interior of the BHDG sample along the z-axis after 5 years.

attributed to the elemental composition difference in the BHDG sample. In this thicker BHDG sample, 4-5 times greater hardness values were measured from top to bottom. Microstructural and elemental differences affect the formation of galvanic cells from the beginning of the corrosion event and accelerate corrosion rate. In this process, a more favorable environment is created for “local” and/or “pitting” corrosion. The composition and surface properties were important for the corrosion products accumulating on the surface during atmospheric corrosion. Therefore, we have realized SEM-EDS analysis for 5th years exposed samples, after abrading the cross sections about 1 mm for three times. This kind of testing was thought to be necessary for making sure previously discussed happenings along cross sections. The obtained results were presented, layer by layer in **Figs. 10 and 11**, for BHDG and CHDG samples, respectively. By doing so, we have targeted to obtain convincing proofs for the way of corrosion progress through the zinc layers obtained by different techniques. In the case of BHDG sample (**Fig. 11**), remarkable vertical cracks and deep caves due to corrosion were clearly seen. This situation is in well agreement with previously presented findings about separate phases of lead and micro galvanic cells, as well as micro defects present in BHDG sample. Once the corrosion starts over the surface, local corrosion cells may grove through the depths of galvanizing layer, due to elementally different regions from side to side. This scenario will certainly lead to formation of red rust on the surface with time. For the sample prepared with CHDG process, the surface is getting oxidized uniformly, due to limitedly soluble corrosion products of zinc are formed on the uniform galvanizing layer (**Fig. 11**).

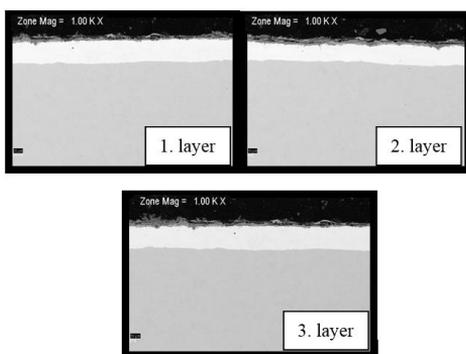
Fig. 11 SEM analysis into the interior of the CHDG sample along the z-axis after 5 years.

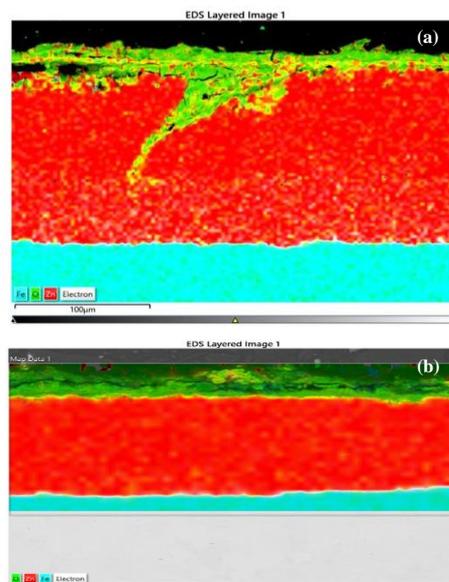
Fig. 12 EDS mapping analyzes for the cross sectional BHDG (a) and CHDG (b) samples achieved after 5 years.

EDS mapping analysis was realized for better illustrating the situation difference between BHDG and CHDG samples, from cross section views, after 5 years, **Fig. 12**. Typically, pitting corrosion progressing through the BHDG sample’s zinc layer is seen.

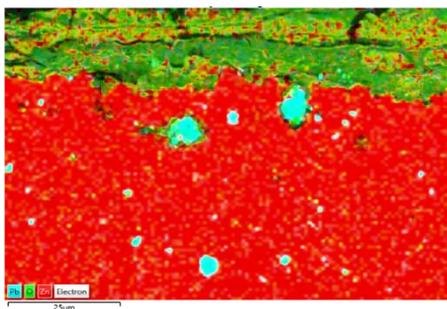
Fig. 13 The effect of Pb micro particles on corrosion of BHDG samples.

This time, the EDS mapping analysis of original (noncorroded) BHDG sample in order to explain the reasons for such severe cavitation risk, during atmospheric corrosion (**Fig. 13**). In the region close to the surface, it was clearly observed that corrosion process was intense around the lead micro particles (light blue) and the oxide corrosion products, green color surrounding the particle. Galvanic couple is formed when the corrosive solution penetrating down the surface (formed by the condensation of the humidity in the atmosphere and increasing its aggressiveness with the pollutants) reaches the part where the lead micro particle is located. This galvanic couple occurs in places where different types of metals coexist and are exposed to corrosive environment, enables corrosion to occur much faster [30]. When lead and zinc are present together, zinc ($E^\circ = -0.763 \text{ V}$) is much more active than lead ($E^\circ = -0.126 \text{ V}$).

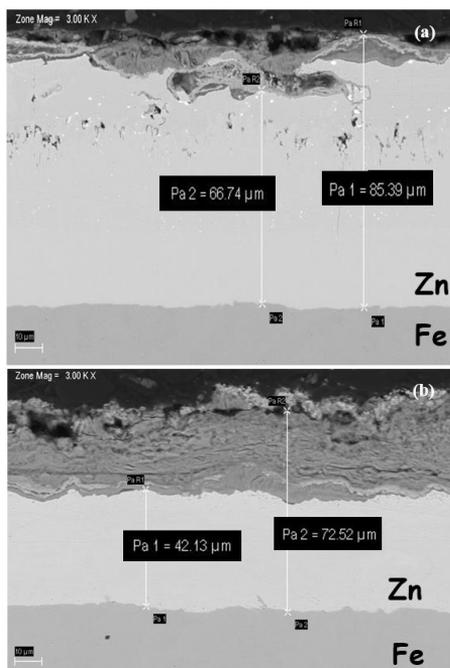
Fig. 14 Oxide films after 5 years atmospheric corrosion for BHDG (a) and CHDG (b) samples.

For a more detailed analysis for oxide thickness change in BHDG and CHDG samples against the zinc loss due to corrosion, the cross-sectional analyses of the samples taken at the end of 5 years were given in **Fig. 14**. The thickness of the galvanized layer on the steel surface is not the same everywhere, depending on the underlying surface texture and other variables. Therefore, zinc thicknesses varying between 90-100 μm for BHDG sample and 50-60 μm for CHDG sample were measured before the atmospheric corrosion tests. It has been determined that the samples exposed to C4 class atmospheric corrosion for 5 years have decreased up to $\sim 33 \mu\text{m}$ for BHDG. At the same time, the maximum thinning of the CHDG sample was around $\sim 18 \mu\text{m}$. As a result, the performance of the most risky region should be taken as a basis for red rust formation in a galvanized material.

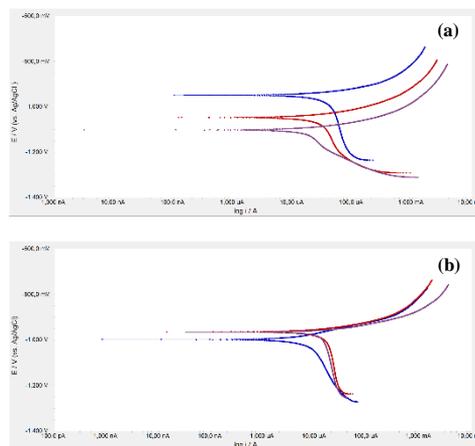
Fig. 15 PD polarization results for BHDG (a) and CHDG (b) samples obtained in 0.05% NaCl solution for 0.5h (blue), 24h (red) and 48h (purple) immersion time.

PD polarization measurements were carried out to investigate the corrosion behavior of BHDG and CHDG samples in 0.05% NaCl solution. PD polarization results recorded in the range of corrosion potential (E_{corr}) \pm 250 mV were given in **Figs. 15a** and **b**. In these curves, the magnitude of the current flowing through the surface is directly dependent on the corrosion rate. The rate and current (as $\mu\text{A cm}^{-2}$) of corrosion were determined by analyzing the anodic ($> E_{corr}$) and/or cathodic ($< E_{corr}$) regions with the methods specified in the relevant standards. The magnitude of this current is directly proportional to the amount of material dissolved/oxidized by corrosion from the surface. Therefore, this method is used to quantitatively compare the corrosion performance of different types of materials [31]. At the end of only 0.5 hours, the corrosion

current densities for BHDG and CHDG samples were determined as 40.5 and 7.2 $\mu\text{A cm}^{-2}$, respectively. It is seen that corrosion rate is 5-6 times faster on the BHDG sample surface.

Over time, corrosion rates tend to decrease as corrosion products form on the surface of both materials. However, in any case the corrosion rate of the BHDG sample is always higher. This is the result of the elemental composition difference, micro particles and defects in the zinc coating of the BHDG sample, as discussed in the previous sections, increasing the corrosion rate. After 2 days, corrosion product deposits formed on the surfaces of the samples. Zn(OH)_2 deposit, which is the main corrosion product on the surface, has a limited stability ($K_{sp} = 1.8 \times 10^{-14}$) and while dissolving slowly, it moves away from the surface by diffusion and into solution. The dissolution of zinc, the formation of Zn(OH)_2 and its separation from the surface by dissolving determine the total corrosion rate. As these steps progress, corrosion rates that change day by day reach a stable value after a while. The corrosion current values were determined as 29.5 and 15.7 $\mu\text{A cm}^{-2}$ after 1 and 2 days for BHDG, respectively. Moreover, these corrosion current values were found as 11.6 and 13.2 $\mu\text{A cm}^{-2}$ after 1 and 2 days for CHDG, respectively. This result is consistent with the comparison results of oxide formation/zinc thinning rates obtained from cross-section SEM analyses in field samples and given in the previous sections.

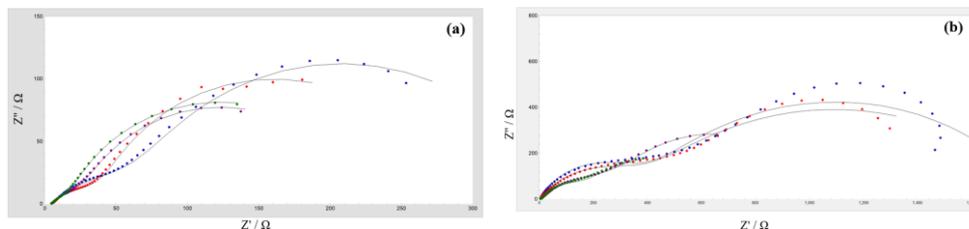
Fig. 16 EIS results for BHDG (a) and CHDG (b) samples obtained in 0.05% NaCl solution for 2.5h (blue), 7.5h (red), 24h (purple) and 48h (green) immersion time.

EIS measurements were carried out and shown in **Figs. 16a** and **b** for BHDG and CHDG samples in 0.05% NaCl solution at different exposure period. From these EIS measurement results, changes of the oxide film on the surface over time and its permeability can be observed directly over the resistance values [32]. It is also seen from EIS results that the corrosion resistance of the passive oxide film on the surface of the CHDG sample, whose surface is zinc, coated with a thickness of 40-50 μm and passivated, is higher.

A small amount of newly formed oxide can better protect the surface with oxides that are the product of passivation previously applied to the surface. Although, more corrosion products form on the surface of BHDG sample with immersion time, they are far from being protective. The obtained EIS parameters were also presented in **Table 7**.
