## TECHNICAL PAPER

## INCIDENCE OF HEAT TREATMENT ON THE CORROSIVE BEHAVIOR OF AISI 316L AUSTENITIC STAINLESS STEEL

## ABSTRACT

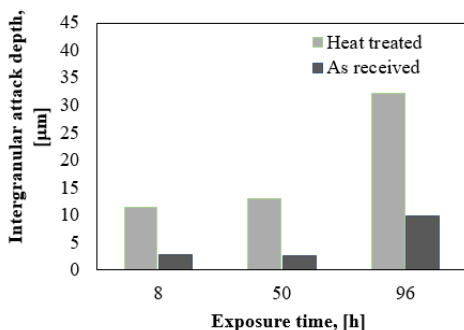
**Fig. 7** Intergranular attack depth as a function of spray exposure time.

On the other hand, the heat-treated samples with a high density of carbides exhibited substantial damage from the beginning of exposure to the saline atmosphere. The average depth of intergranular damage increased from 11 µm at the first 8 hours to more than 30 µm at the end of the test, representing an increase of almost 300% in the attack depth, Fig. 7. In contrast, the as-received sample had a lower damage depth of less than 10 µm after 96 hours. All these measurements were determined using Material Plus 4.5 software.
